THE REHABILITATION OF AJBA CONCRETE DAM

Iztok Leskovar, Researcher¹, Mojca Ravnikar Turk, Researcher²

¹IRMA Institute for research in materials and applications, Ljubljana, Slovenia, ²ZAG, Slovenian national building and civil engineering institute, Ljubljana, Slovenia

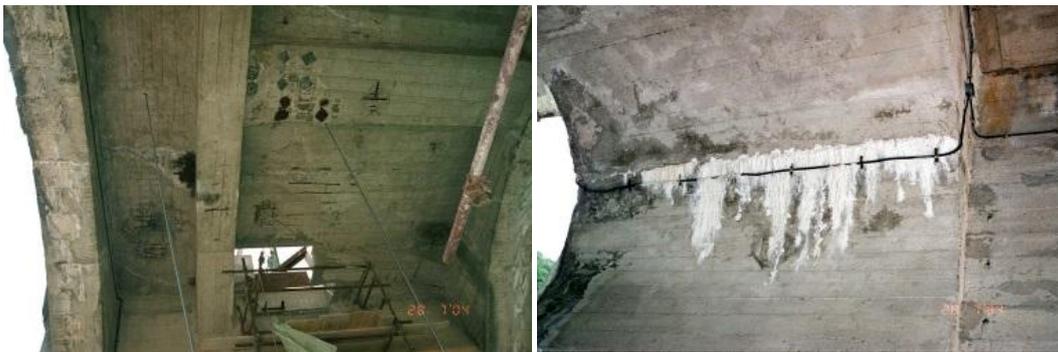
Figure 3 Typical deterioration damages (corrosion, cracks filled with flowstone) in 2004

The examination showed corrosion of the reinforcing bars on all reinforced concrete elements. It was most severe on the bridging elements on the level 120.0 m (see Figure 3) and on the level 111.5 m. A smaller amount of cracks was recorded on the bridging structure above the spillway and on the housing of the new power station. The main cause for the extensive corrosion were very thin reinforcing bar protective layers and deep carbonisation of concrete, that on several locations exceeded the thickness of protective concrete layer. The corrosion was most severe on the bottom surface of the ‘upper deck’, where leakage through the deck was observed. Precipitation water penetrated thru concrete and wetted the bottom surface of the reinforced concrete slab.

Open construction joints and numerous cracks were clearly visible on all sections of the dam. Most of them were initially caused at the time of construction due to applied technology of construction. At these cracks leakage and flowstone were observed (see Figure 3). The width of cracks was up to 3 mm. It was necessary to seal the open joints and cracks to re-establish integrity of each construction element and prevent further degradation of concrete.

For injection of wide and long cracks and joints up to approximately 0.3 mm wide cement material and polyurethanes that swell in the contact with water were used. Most of the cracks, where leakage had been evident, were sealed with the polyurethane rasins. Construction joints as well as active cracks of small width were filled with the injection of elastic epoxy rasin on water base to achieve good adhesion on moistened concrete surfaces.

On the bridging structures and other reinforced concrete elements, where corrosion of reinforcing bars has been detected, the usual rehabilitation procedure was used. Firstly concrete around corroded rebar was removed, exposed rebar was cleaned and new concrete layer for corrosion protection was applied.

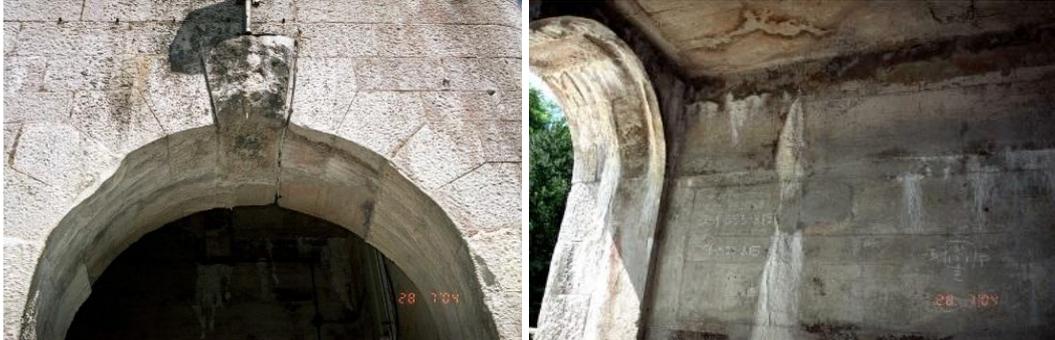
Stone facing was mostly in a very good condition (Figure 4). Some destruction was recognised within joints, where flowstone was found due to leakage thru concrete elements and further thru joints. Stone facing was harmed on one pier in a larger scale due to

explosion of a bomb during the World War II. Explosion caused cracks and lamination of some stone blocks as well as crumbling of stone blocks.

Figure 4 Stone facing with joints filled with flowstone in 2004

Rehabilitation of stone linings consisted of repair of damaged joints and repair of severely damaged stone blocks with bonding of new stone pieces in epoxy mortar onto existing stone blocks. All stone surfaces were cleaned with sandblasting (Figure 7). Joints between sand blocks were repaired with polymer modified mortar.

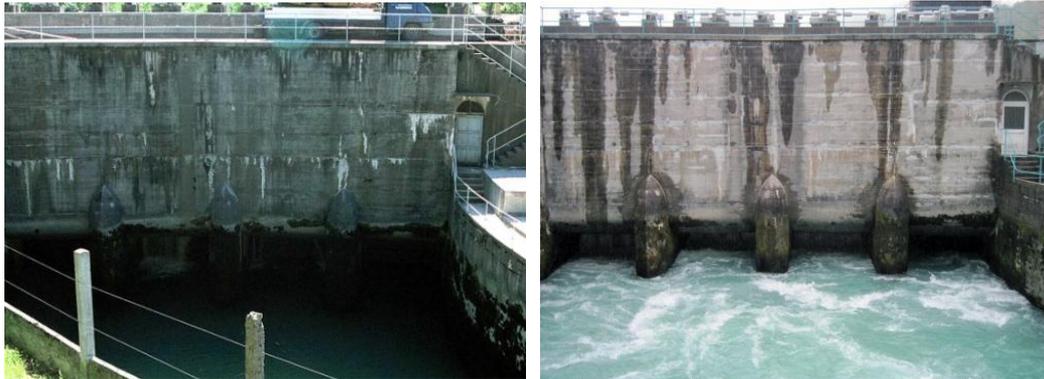
Figure 5 Intake structure HP Plave 1 before rehabilitation in 2004 and five years after it

On the frost affected concrete surfaces of the Ajba dam, firstly all deteriorated layers of concrete were removed with waterblasting equipment and light shock hammers. Then in the case of large areas dry-mix shotcrete method was used. The dry components comprised mortar and polymer fibers for micro-reinforcement. Mineral additives ensured a low percentage of waste and good cohesiveness of mortar. Sprayed mortars were finally trowelled and in most cases the application of additional final layer was not necessary. For small-scale degraded concrete areas reparations were carried out by hand or by using smaller machines for wet placing of polymerized cement mortar (PMM).

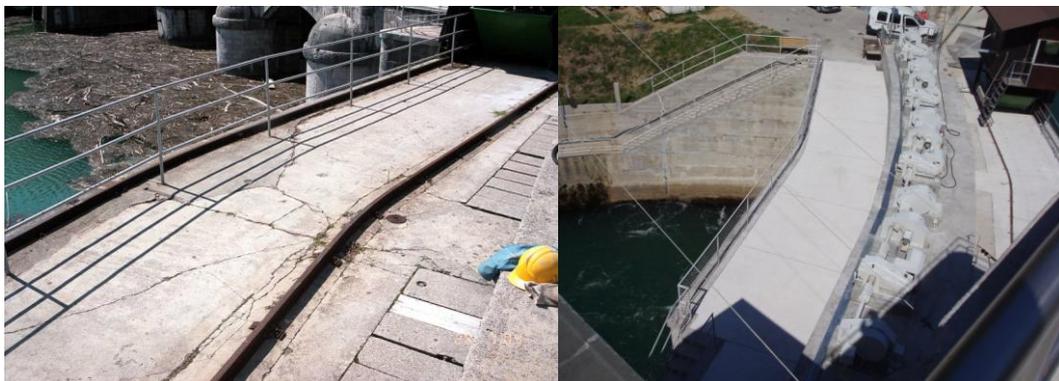
Figure 6 pavement of the intake structure before rehabilitation in 2004 and after it

Rehabilitation of existing pavements including new waterproofing protection was performed with polymerized cement concrete reinforced with steel fibers (Figure 6).

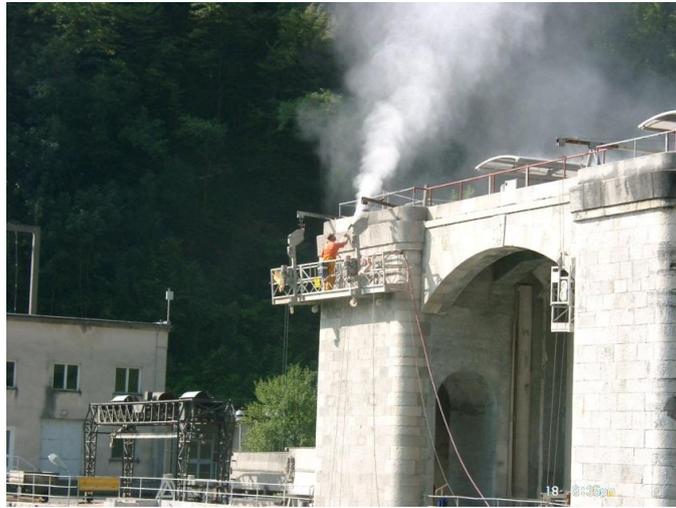
Figure 7 Sandblasting of stone facing on the right pier at the deck level (121m) in 2006

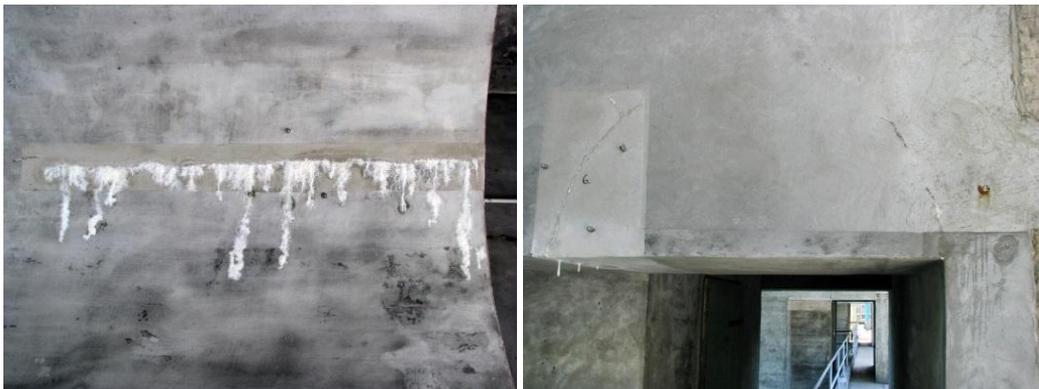
Figure 8 Reappearance of small number of cracks (in 2011)

Five years after rehabilitation works were finished most of the former cracks and joints are still closed and not visible. At some locations, especially where leakage was not entirely prevented, the cracks and flowstone deposits reappeared (Figure 8).
