THE REHABILITATION OF AJBA CONCRETE DAM

Iztok Leskovar, Researcher¹, Mojca Ravnikar Turk, Researcher²

¹IRMA Institute for research in materials and applications, Ljubljana, Slovenia, ²ZAG, Slovenian national building and civil engineering institute, Ljubljana, Slovenia

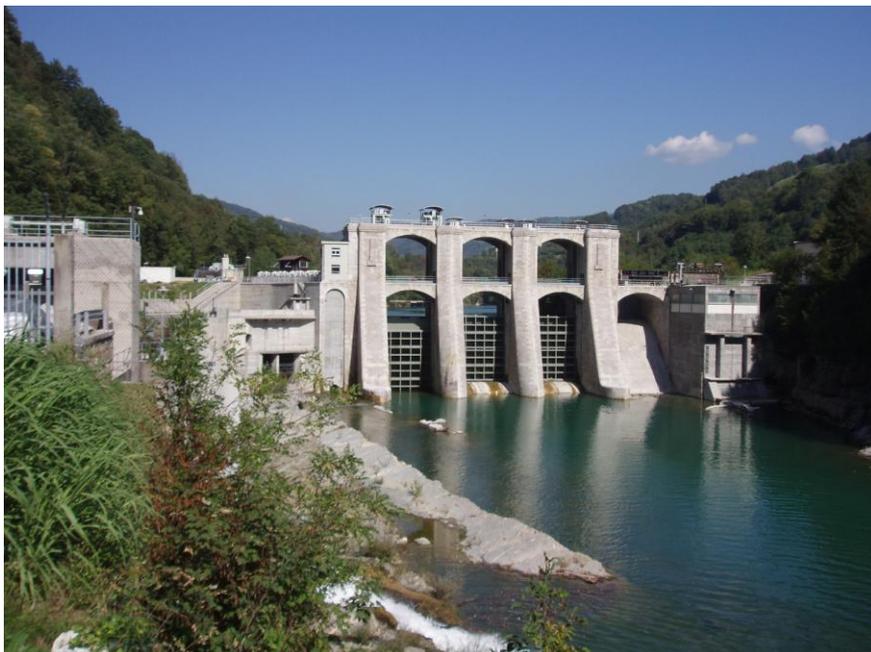
Figure 1 Ajba dam (2012)

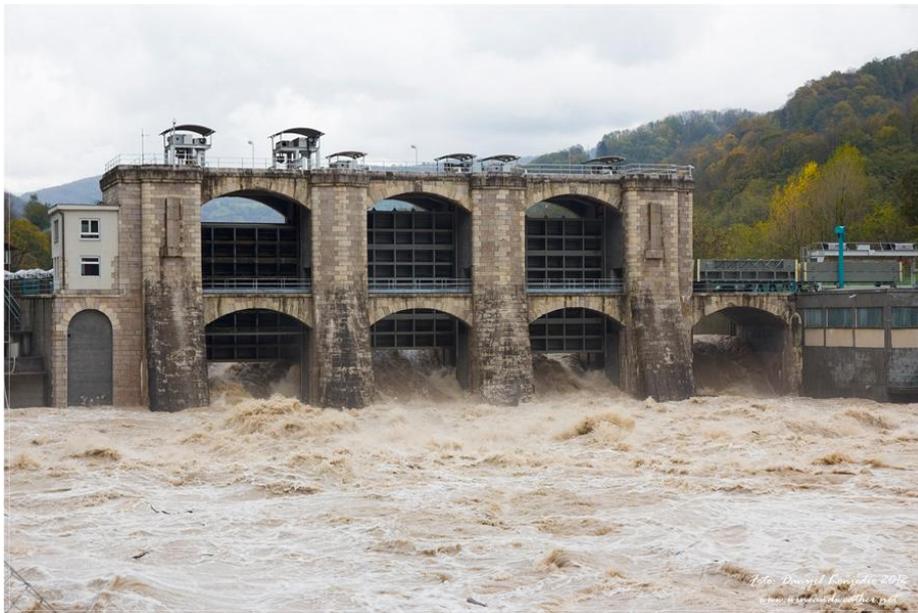
The average flow of Soča River is around 100m³/s, but the differences between low and high waters are very high (Figure 2). On the 5th November 2012 at the gauging station near Ajba the flow reached 2400m³/s.

Figure 2 Ajba dam on 5th November 2012 (<http://www.wineandweather.net/2012>)
